COVID-19 ACTION ON WATER AND SANITATION

A SHORT CASE STUDY ON COMMUNITY SERVICE DELIVERY MONITORING IN 6 INFORMAL SETTLEMENTS IN KWAZULU-NATAL

BUILT ENVIRONMENT SUPPORT GROUP

14 January 2021

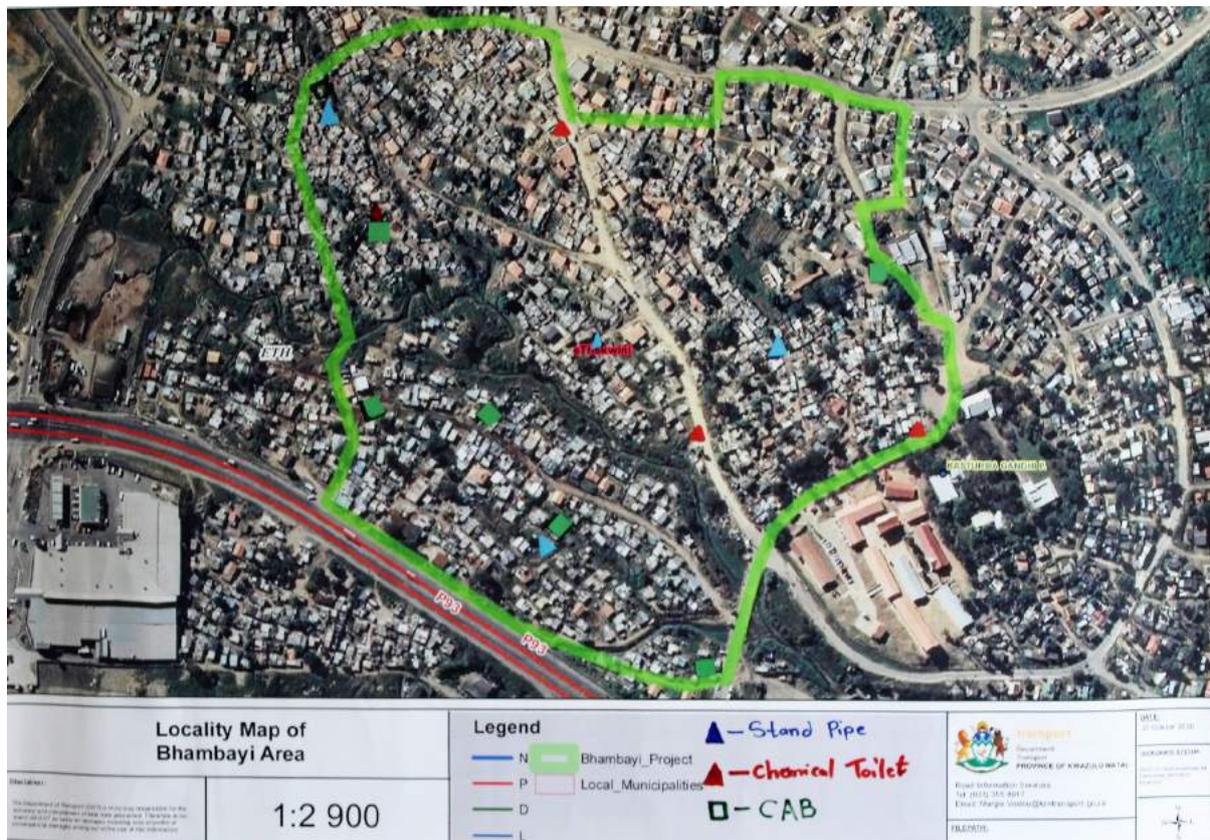
Figure 2: Bhambayi southern section

- 7 Communal Ablutions Blocks, 5 of which were confirmed to be closed and/or largely dysfunctional at the time of a technical field survey in October 2020. This is due to a combination of broken taps, flush toilets, and showers, and sewer blockages.
- 4 communal standpipes. 1 standpipe in the centre of the north-south axis had very low pressure, most likely due to the plethora of informal water connections that existed before the communal services were installed. Additionally, construction of the Juba Blose Road has led to water interruptions of up to 2 days in the central section of the settlement.
- 4 chemical toilets. They are emptied regularly after some initial teething problems, but 2 of them were found to have broken door handles, no toilet seat, and were unclean. In December, a contractor began installing a series of VIPs.⁴

The distribution of facilities is reasonable, with access to most households being within 200 metres. The challenge is the routine level of disrepair which creates conditions where residents are forced to walk further to the next nearest CAB (which may also be closed) or relieve themselves in the bush.

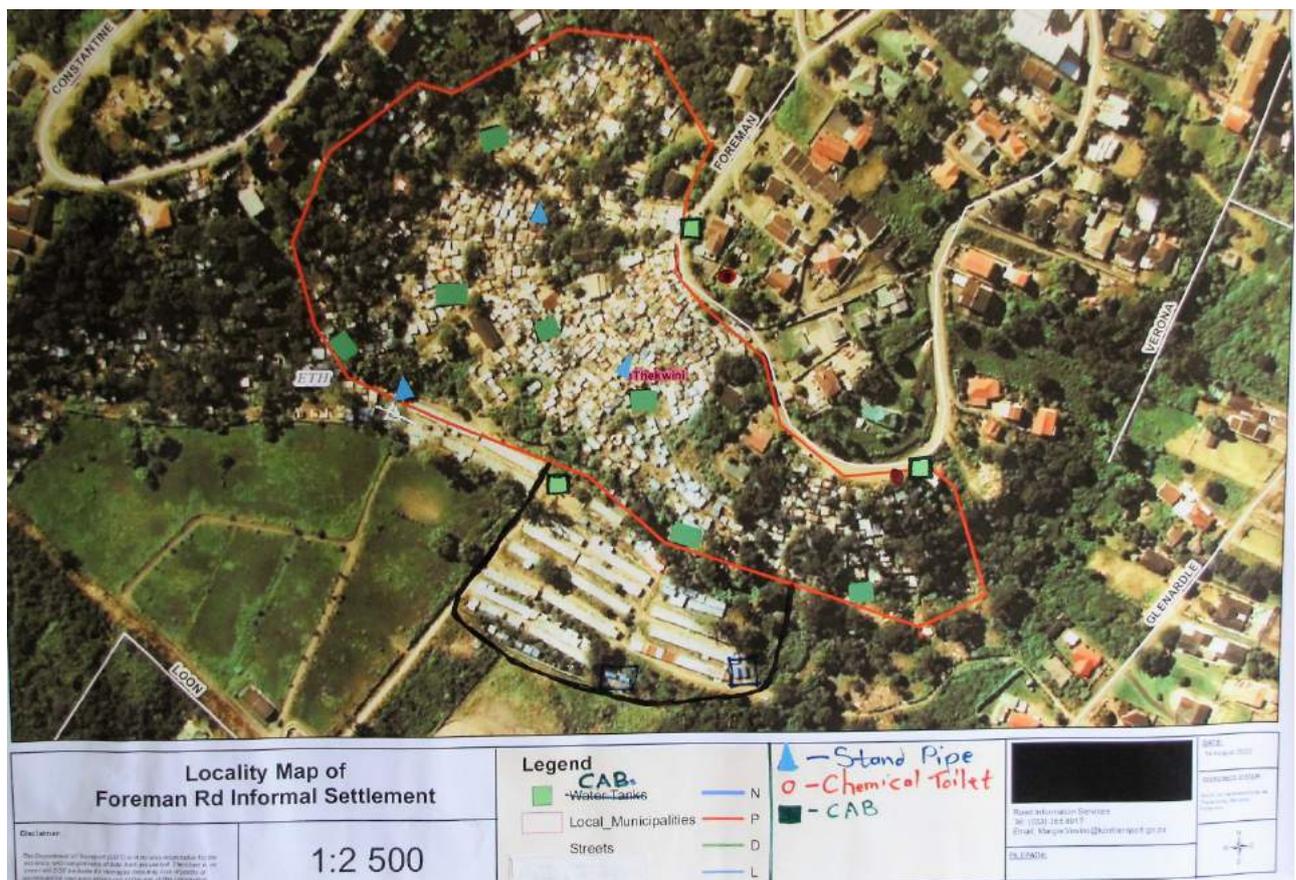
Figure 2: Aerial photograph showing locations of interim services

The population of Foreman Road is estimated to be 2,900 households. The settlement is serviced mainly by 10 Communal Ablution Blocks (CABs). At the commencement of fieldwork in August, 5 of the CABs were closed for repairs. Faults were reported routinely to the municipality or on-site caretakers. As at November, 2 CABs were fully functional, 6 were partly functional, and 2 were permanently closed. Faults were mainly broken taps and/or showers, broken or vandalized toilets, and sewer blockages.

In addition to the CABs, there are 3 communal standpipes. Recently, 2 chemical toilets were stationed on the taxi route along the north eastern boundary of the settlement. They are not regularly emptied and were reported to have broken door handles and no toilet seat.

Water pressure was found to be adequate throughout, with a 5-litre container filling in 15 seconds. The spatial distribution of CABs, with the 3 additional standpipes, meets the yardstick of a 200 metre access range. A report-back meeting with the community leadership and volunteers, held on 10 December, confirmed that there were no issues with water supply, provided the CAB taps are kept in serviceable condition.

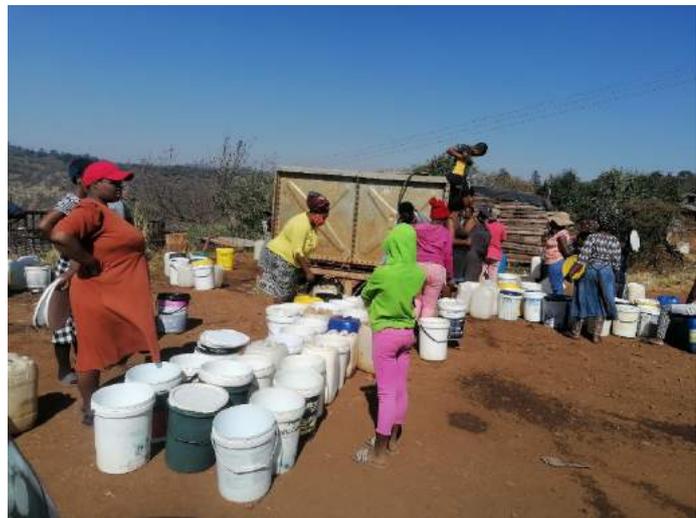
- There are 2 single tanks located within 100 metres of each other in the northern section of the settlement.
- There are 2 pairs of tanks located within 150 metres of each other in the central section. 1 of these tanks was found to be vandalized, without a tap and burnt out.

- In the southern section of the settlement, there is a steel tank with 3 taps.
- Some 40-50 households in the southernmost section of the settlement are outside the 200m radius of the nearest water station, due to lack of road access. uMngeni Water has graded the road for access to maintain the water-main valve located in the far-south section of the settlement. This ultimately gives access to the mobile service. It is possible to widen the access road at that point in order to provide for another water station (see Figure 2 below and Recommendations).

- There are 3 communal standpipes located along the boundary of the Howick Golf Club. Volunteers shared that these stand pipes were connected by the golf club owners to try and assist the settlement with access to water. Water pressure is about 50% of norm on 2 standpipes – it took 1 minute, 5 seconds to fill a 5-litre container.

The far south section of the settlement does not access to water, they need to be supplied with 3 x 5000-litre storage tanks. The service road graded by Umgeni Water will need to be widened and gravelled to cope with wet weather conditions. An intensive sanitation programme is needed for the area, given the unhygienic conditions faced by residents, and that the settlement lies directly above the Umgeni River and Howick CBD. This would involve de-commissioning the informal pit latrines dug by residents and replacing them with a combination of 50 VIPs and chemical toilets along the main access road. The chemical toilets can be stationed along the main access road for ease of access, while VIPs can reach deeper into the settlement with the aid of a honeysucker for emptying, at lower operational cost.

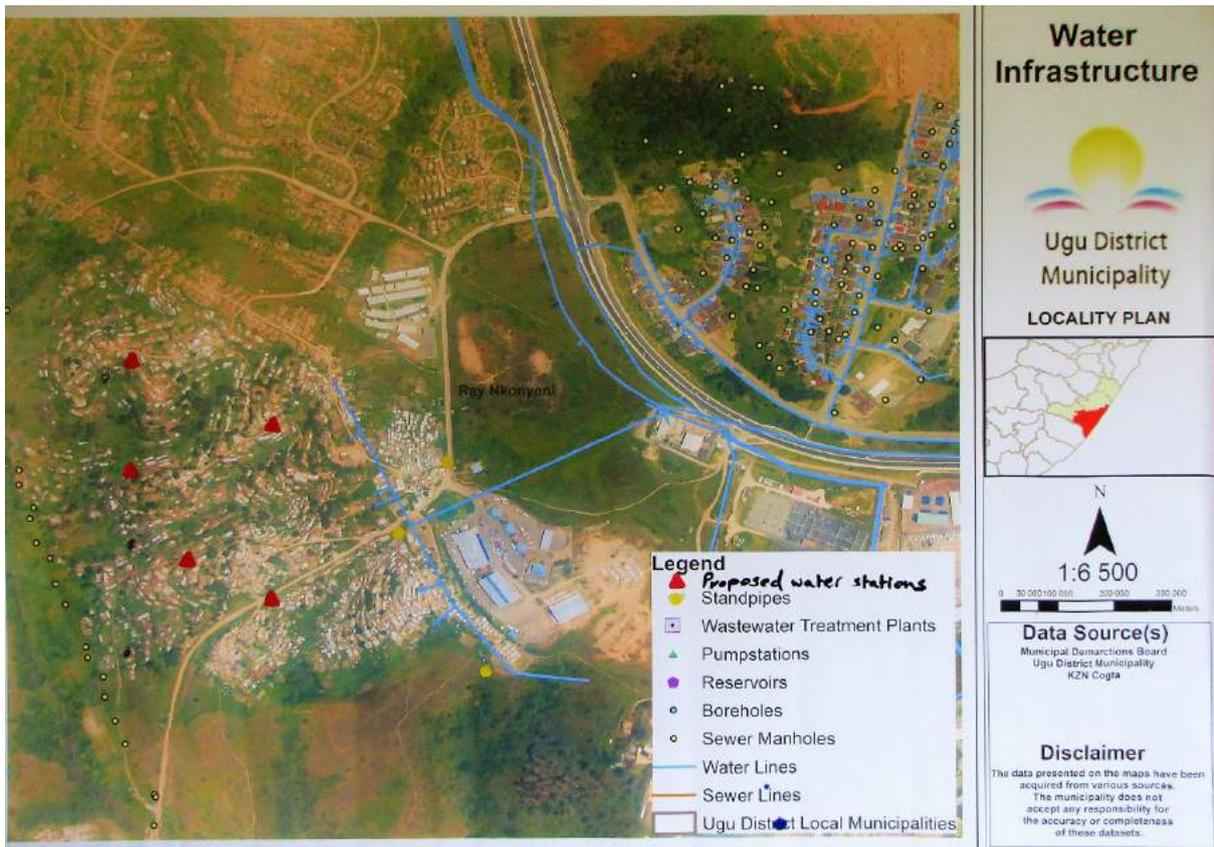
Figure 3: Location of current and proposed water services

The population of Mkhholombe is estimated from aerial photography to number 2500 households. The entire settlement depends on 3 communal standpipes (marked in yellow in *Figure 3*). The first standpipe, as one enters the settlement, is vandalized and there is no tap -- residents use a pipe with a ball valve to control water flow. The water main at this collection point is exposed above surface and leaks. Water pressure is adequate.

The second and the third standpipes have plastic taps that are often damaged. Water pressure is adequate, however there are usually queues of residents with 20-litre containers, especially in the morning and evening peak hours. Many residents draw water for general purposes from the Bhooyi River, over 200 metres below the settlement.

A field survey conducted in November revealed that there are leaks on the bulk water main where it crosses the Bhooyi River.

The community is requesting that the District provides 10 x 5000 litre static water storage tanks -- to be placed in pairs in 5 identified locations (see red triangles on *Figure 3*), where there is ready road access and within 200 m walking distance -- serviced by water tanker at least 3 times a week. In the longer term, water pressure should be sufficient to provide limited water reticulation into the settlement and reduce dependency and expense on mobile service.
