How geology puts Durban and other KZN cities at risk of landslides

By Charles MacRobert

28 Apr 2022

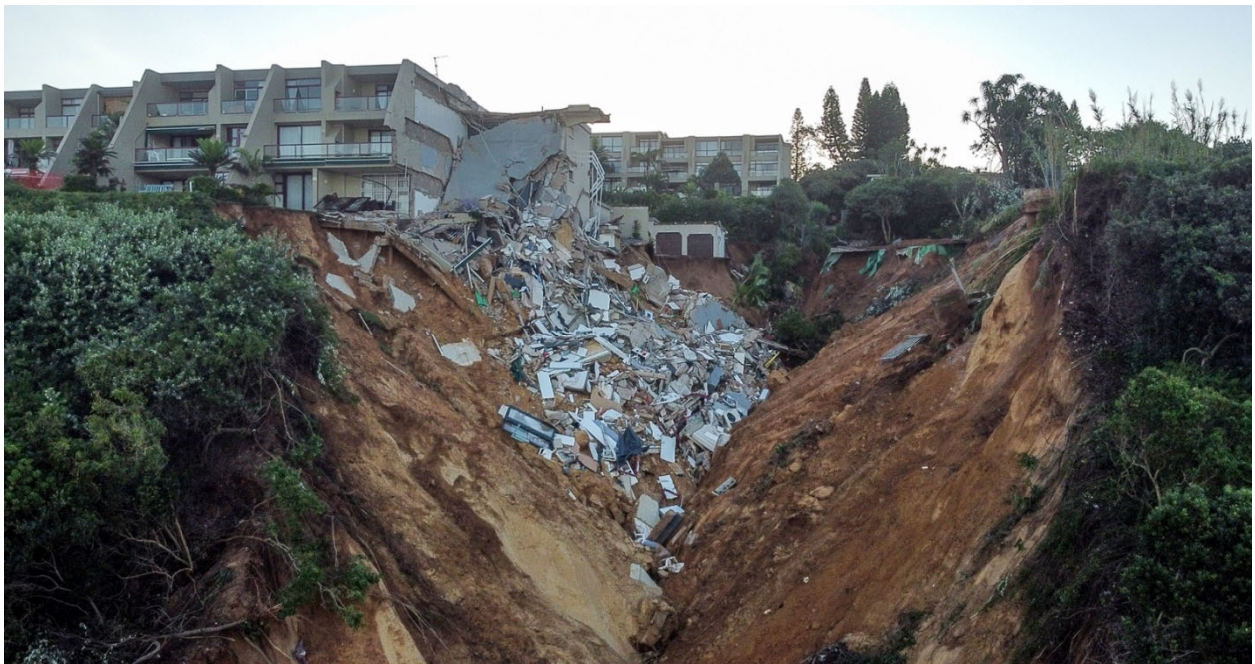
This drone image shows the destruction at Umdloti beach north of Durban, on April 14, 2022. At least 400 people died following the destructive rainfall that swept away homes and destroyed infrastructure in the city of Durban and KwaZulu-Natal province. (Photo: Shiraz Mohamed)
