BUILT ENVIRONMENT SUPPORT GROUP

REPORT ON IMPACT OF COVID-19 EMERGENCY WATER & SANITATION ROLL-OUT IN 14 LOW INCOME SETTLEMENTS IN KWAZULU-NATAL

November 2020

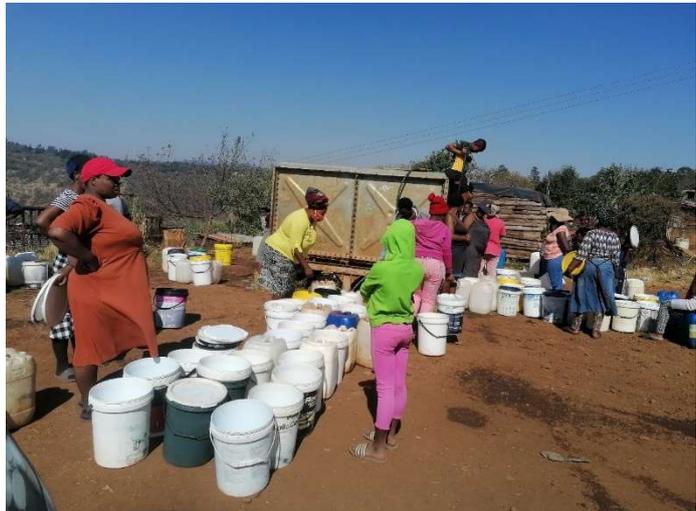
Women and children are the most affected by water shortages as they do all the collecting.

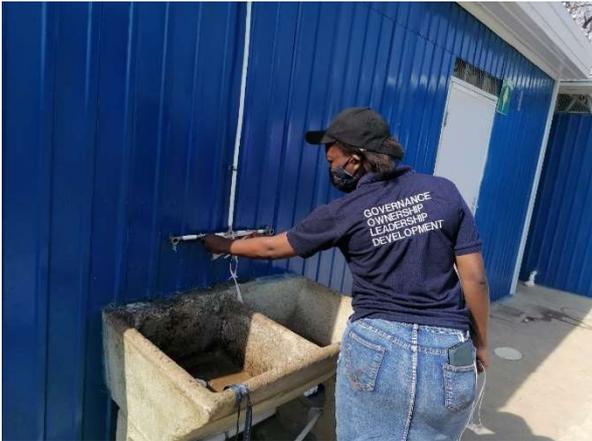
Repairs to Communal Ablution Blocks being checked in Bhambayi

In eThekweni Metro, a repair contract for the Foreman Road CABs that was reported to commence on 1 June failed to materialise. 3 additional standpipes and 3 chemical toilets were provided. Bhambayi was more fortunate with extensive repairs to their CABs, but they were reportedly broken again within days. This is referred to again under Conclusions and Way Forward. There was no further activity in the 6 settlements within Clairwood/Ward 32, which was the most difficult to monitor due to the settlements being relatively small and scattered and without any unified leadership.

- Foreman Road – repair of CABs, additional chemical toilets.
- Bhambayi – repair of CABs, additional chemical toilets.
- Shiyabazali – potential reblocking to the western section along the Umgeni River valley to allow access to water tanker, new water station.
- Nkanini – improved road access to 2 remote sections, frequency of tanker delivery.
- Hlaleleni -- frequency of tanker delivery, chemical toilets for 300 households without sanitation.
- Mkhholombe – broader distribution of standpipes/water stations, provision of toilets.
